Safety Alert:
"Reduced Visual References
Require Vigilance"

CFIT Accident: VFR into IMC

Spatial Disorientation Accident:
Dark Night VMC
Dennis J. Diaz, IIC

Spatial Disorientation Accident

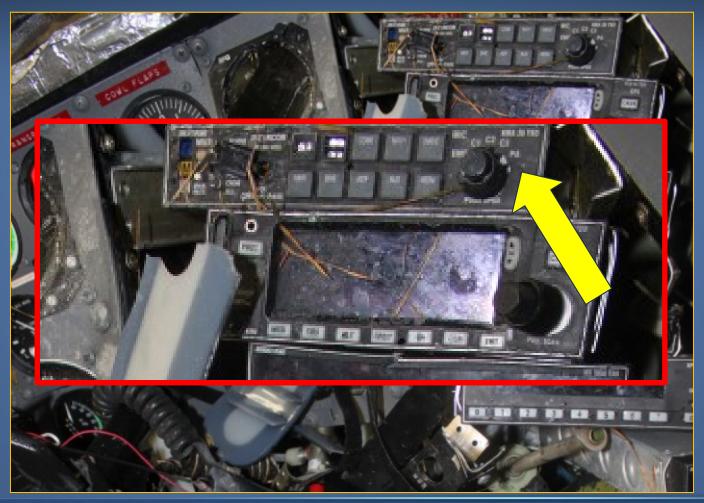
Audio Panel

- Fully understand how to operate all onboard systems
- Divert flight after encountering abnormalities
- Terminate flight before nightfall
- Find airport with continuous night lighting, without disorientation hazard
